1999 GMC Sierra Radio Replacement Radio Replacement

Replacing a radio in a 1999 GMC Sierra SLE. Based off replacing a stock radio with a XO Vision XD107BT radio.

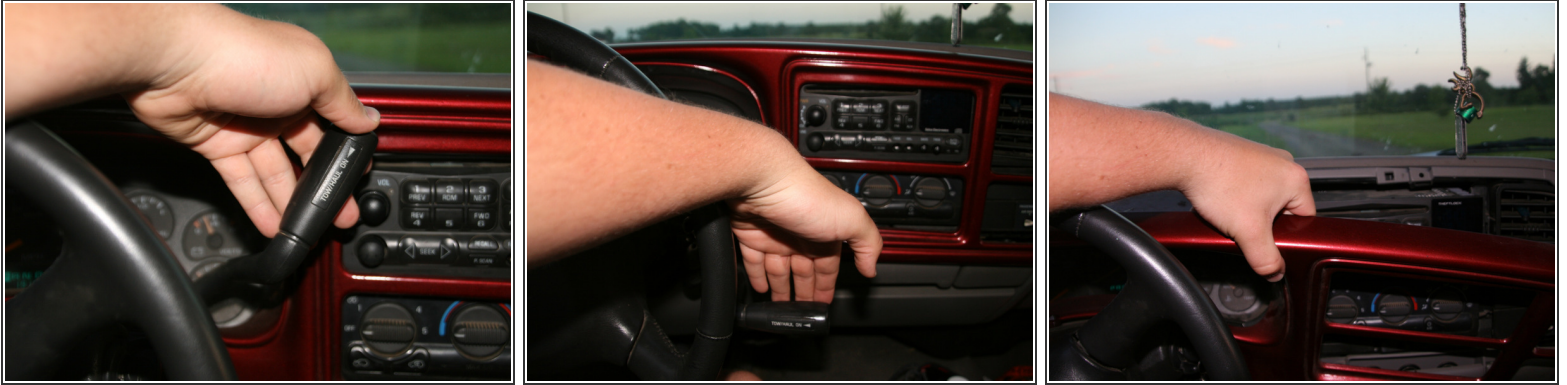
Step 1 — Radio

- Use the gear shift to shift the truck from 'Park' to '1st Gear' so that the dash face is easily accessible.
- Pop the dash face off, and place it to the side until the radio has been replaced

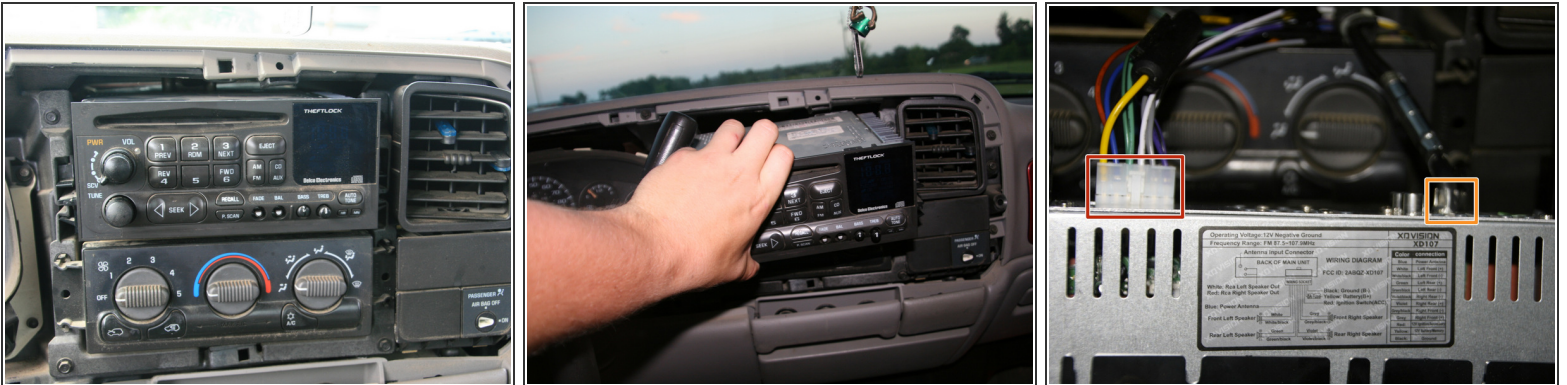
Step 2

- Remove the radio from its place.
- Remove the bundled cable connector from the back of the radio unit.
- Remove the antenna plug from the back of the radio unit.

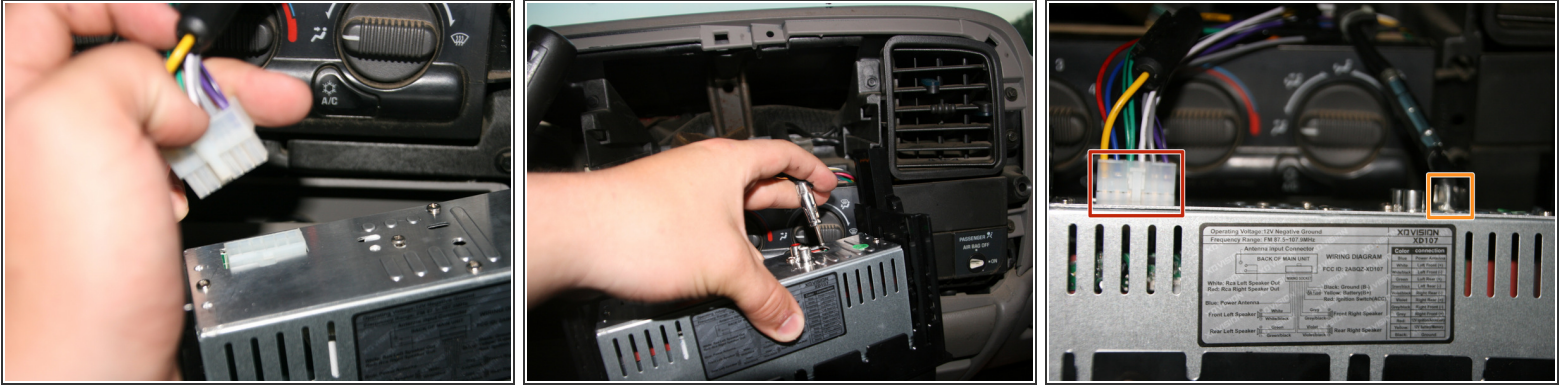
Step 3

- Attach the radio plug to the back of the new radio.
- Also, attach the antenna chord to the back of the new radio.

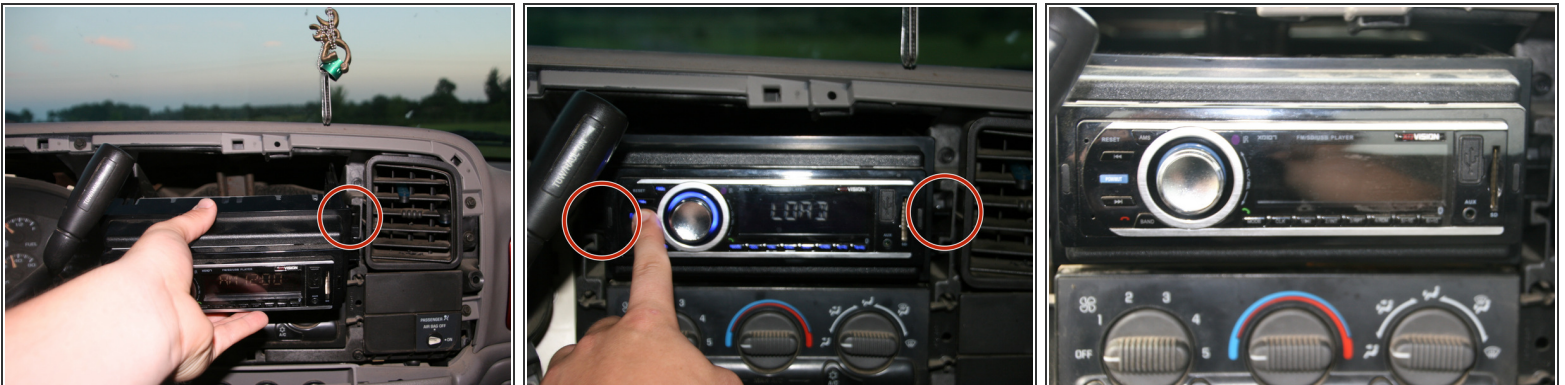
Step 4

- Align the slots along the sides of the new radio with the ones in the dash.
- Push new radio in until you hear a 'pop' sound, telling you the new radio is in place.
- Press the power button on new radio to insure that it works properly.

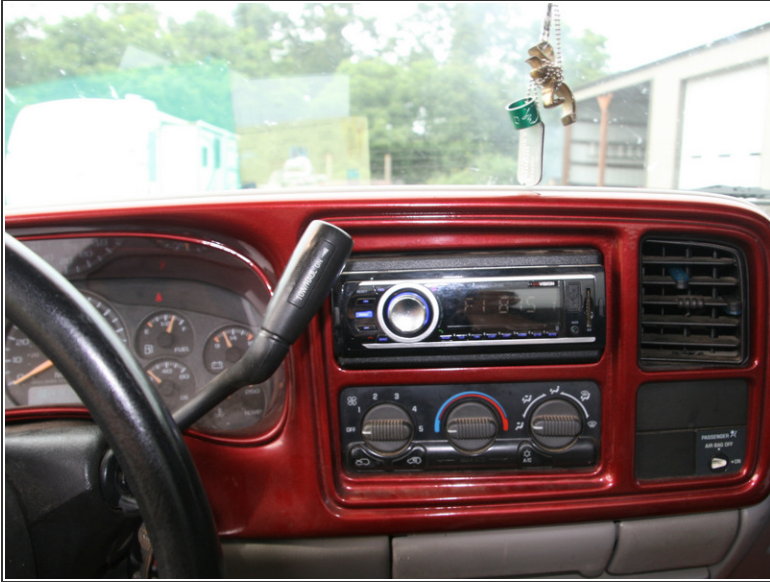
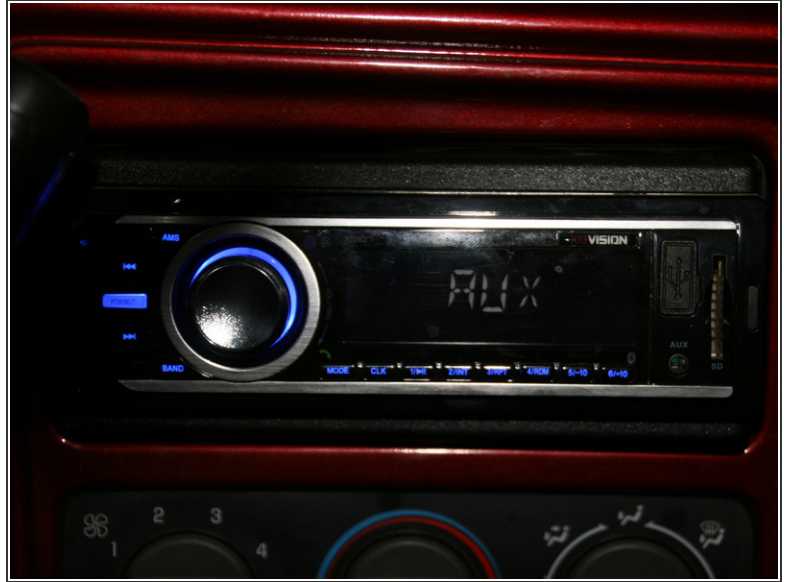
Step 5

- Replace dash face! Then you are finished!
